Manhole Inspection Summary

Manhole # S35SS1028MH

Location Address: **409 TANTALLION CT**

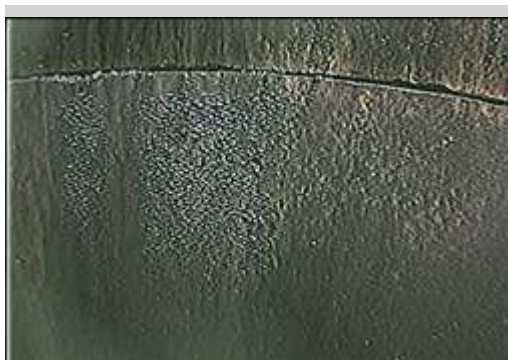
Defect

Infiltration: ☐ None ☒ **Joint** ☐ Cracks ☐ Mortar ☐ Roots ☐ Wall

Barrel infiltration.

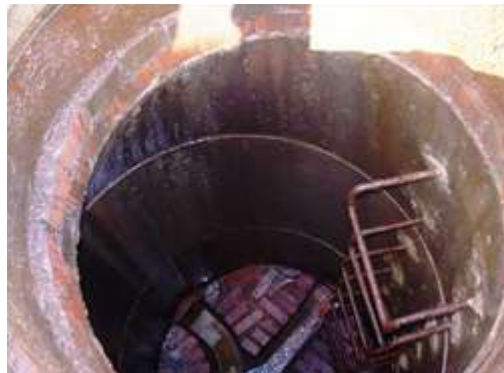
Defect

☒ **Leaks**

Condition: ☐ Sound ☐ Cracked ☐ Root Intrusion ☐ Loose Brick ☒ **Deteriorated**

Infiltration: ☐ None ☒ **Joint** ☐ Cracks ☒ **Mortar** ☐ Roots ☐ Wall

Frame leaks. Adjustment deterioration and infiltration. Corbel infiltration - other side.

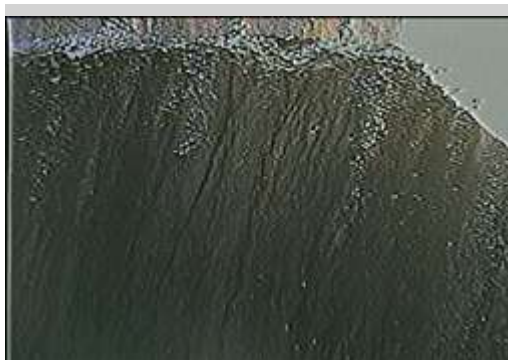
Defect

Infiltration: ☐ None ☒ **Joint** ☐ Cracks ☐ Mortar ☐ Roots ☐ Wall

Corbel infiltration.

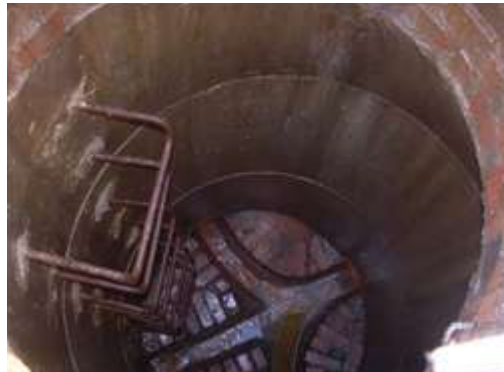
Defect

Frame leaks. Adjustment deterioration and infiltration.

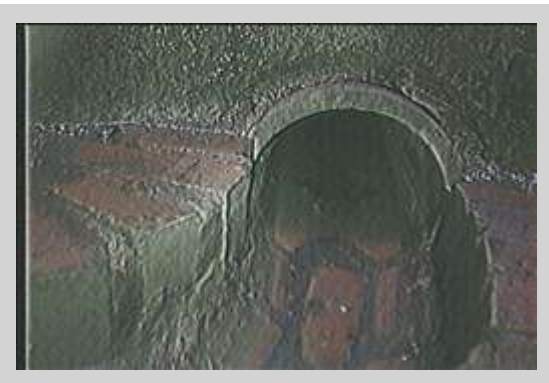
8 in. Circular Gravity Sewer Pipe In @ 3 O'Clock

Infiltration: **Evidence** Pipe Seal Cond: **Unknown**

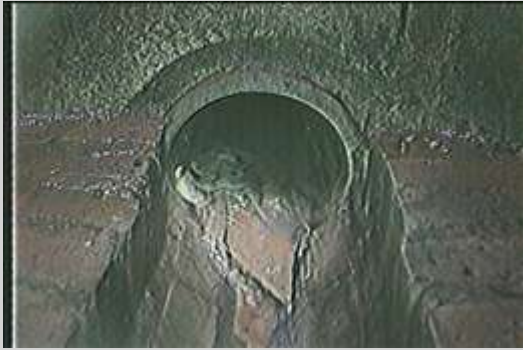
Pipe In @ 6 O'Clock

Deposits: ☐ None ☐ Mud ☐ Sludge ☒ **Debris** ☐ Grease

Silt Depth: **0** (in.) Deposits Extent: **Light**

Infiltration: **Evidence** Pipe Seal Cond: **Unknown**

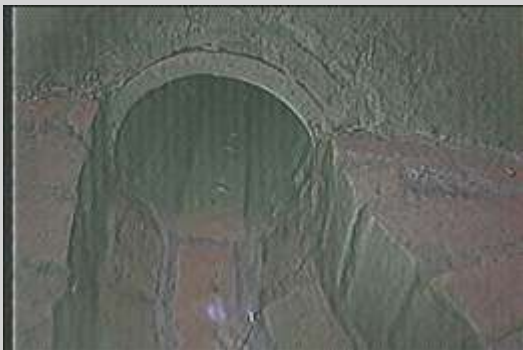
Pipe In @ 9 O'Clock

Infiltration: **None** Pipe Seal Cond: **Cracked**
